**Flood Control Project Maintenance
Levee Inspections****LMA District Cover Sheet
Spring 2014 Levee Inspection Results****Reclamation District No. 0108 River Farms**

Levee Inspection Report By Mile - Spring 2014

Reclamation District No. 0108 River Farms

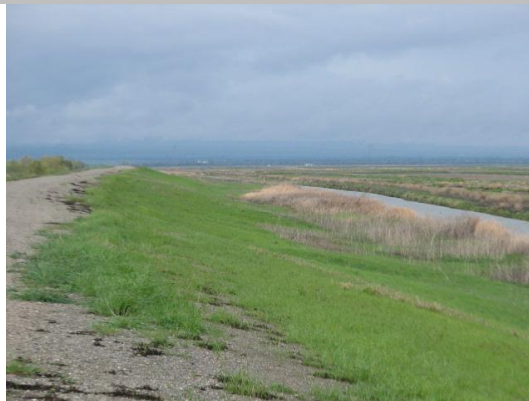
Photo 1 of 1 : johngw_s_20140401_692.jpg

LM Start	0.11	Rating **	A	Issue No.	8
LM End	20.58	Issue Type +	Ma	Location *	LS
Category	Earthen Levee			GPS Latitude/Longitude	
				Start	End
Item	Vegetation			38.823139 °	39.033825 °
				-121.797616 °	-121.993247 °
DWR ID	DWR_RD0108_01_s_2014_8				
Action/Comments					
Control annual grass and weeds on the levee slopes and easements. Inspector Comments: The majority of the vegetation is less then 6 inches.

The vegetation complies with standards. Spring 2014

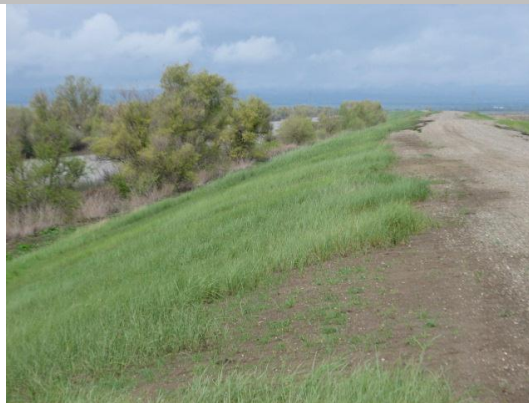
Photo 1 of 1 : johngw_s_20140401_693.jpg

LM Start	0.11	Rating **	A	Issue No.	1
LM End	20.58	Issue Type +	Ma	Location *	WS
Category	Earthen Levee			GPS Latitude/Longitude	
				Start	End
Item	Vegetation			38.823139 °	39.033825 °
				-121.797616 °	-121.993248 °
DWR ID	DWR_RD0108_01_s_2014_1				
Action/Comments					
Control annual grass and weeds on the levee slopes and easements. Inspector Comments: The majority of the vegetation is less then 6 nches tall.

The vegetation complies with standards. Spring 2014

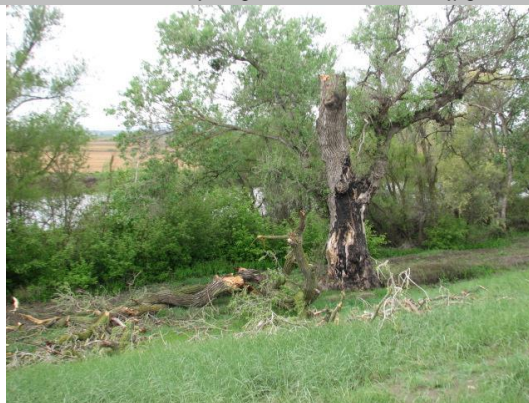
Photo 1 of 1 : johngw_s_20140401_695.jpg

LM Start	5.19	Rating **	M	Issue No.	10
LM End	5.19	Issue Type +	En	Location *	WS
Category	Earthen Levee			GPS Latitude/Longitude	
				Start	End
Item	Encroachments			38.846086 °	38.846086 °
				-121.886834 °	-121.886834 °
DWR ID	DWR_RD0108_01_s_2014_10				
Action/Comments					
Tree or limb

Tree limbs are along the toe of the levee. Tree is slowly dying and could be a hazard to the levee. Spring 2014

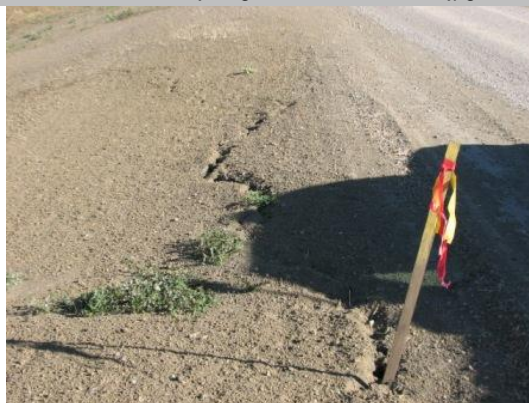
Photo 1 of 2 : johngw_s_20140306_869.jpg

LM Start	9.28	Rating **	A/W	Issue No.	279
LM End	9.28	Issue Type +	Ma	Location *	WS
Category	Earthen Levee			GPS Latitude/Longitude	
				Start	End
Item	Slope Stability			38.897452 °	38.897452 °
				-121.914680 °	-121.914680 °
DWR ID	DWR_RD0108_01_f_2013_279				
Action/Comments					
Repair slope instability.

Slope stability with cracking 1-2 inches open and 12 inches deep Fall 2013 The district is monitoring the site.

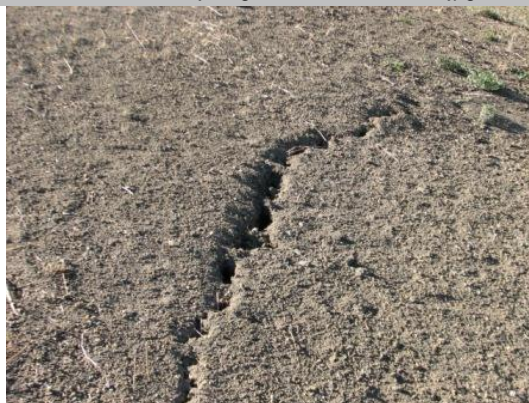
Photo 2 of 2 : johngw_s_20140306_870.jpg

LM Start	9.28	Rating **	A/W	Issue No.	279 (cont)
LM End	9.28	Issue Type +	Ma	Location *	WS

The cracking runs in a horseshoe pattern on the levee slope Fall 2013

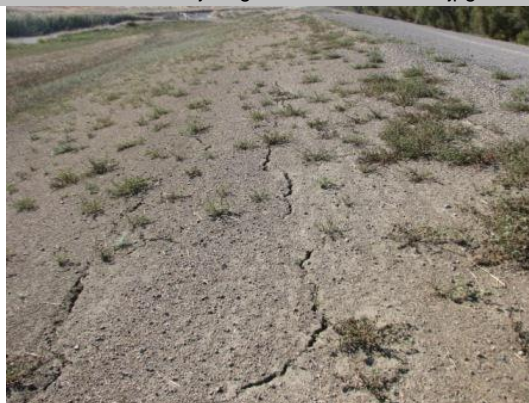
Photo 1 of 1 : johngw_s_20140306_868.jpg

LM Start	9.28	Rating **	A/W	Issue No.	278
LM End	9.28	Issue Type +	Ma	Location *	LS
Category	Earthen Levee			GPS Latitude/Longitude	
				Start	End
Item	Cracking			38.897453 °	38.897453 °
				-121.914680 °	-121.914680 °
DWR ID	DWR_RD0108_01_f_2013_278				
Action/Comments					
Monitor and have inspected by geotechnical engineer.

Cracking on the landside levee slope Fall 2013

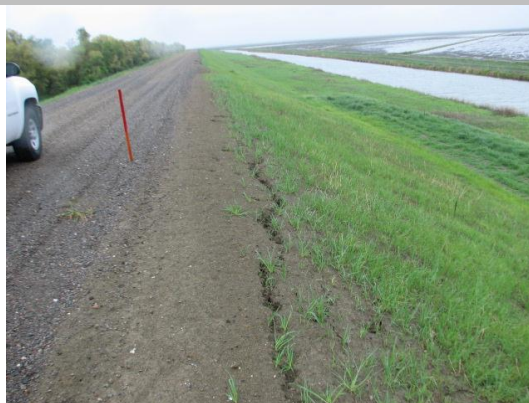
Photo 1 of 1 : johngw_s_20140401_696.jpg

LM Start	13.75	Rating **	M	Issue No.	11
LM End	13.75	Issue Type +	Ma	Location *	LS
Category	Earthen Levee			GPS Latitude/Longitude	
				Start	End
Item	Cracking			38.958947 °	38.958947 °
				-121.915623 °	-121.915623 °
DWR ID	DWR_RD0108_01_s_2014_11				
Action/Comments					
Monitor and have inspected by geotechnical engineer.

Cracking along the shoulder of the levee crown. Spring 2014

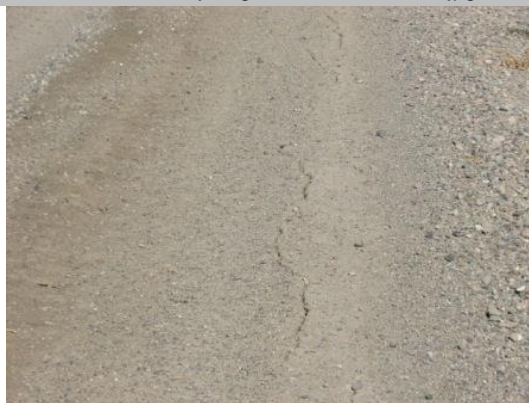
Photo 1 of 2 : johngw_s_20140306_871.jpg

LM Start	14.22	Rating **	A/W	Issue No.	280
LM End	14.24	Issue Type +	Ma	Location *	LS
Category	Earthen Levee			GPS Latitude/Longitude	
				Start	End
Item	Cracking			38.964848 °	38.965205 °
				-121.920245 °	-121.920537 °
DWR ID	DWR_RD0108_01_f_2013_280				
Action/Comments					
Monitor and have inspected by geotechnical engineer.

Small cracking along the shoulder of the crown, fall 2013.

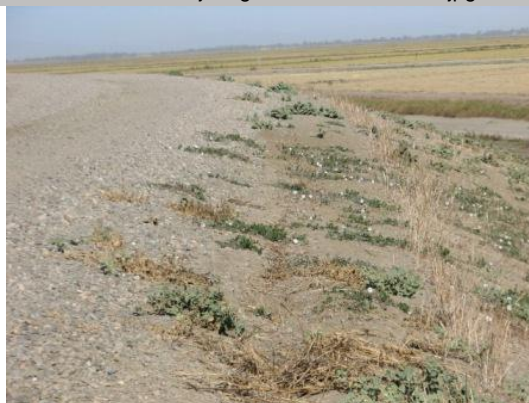
Photo 2 of 2 : johngw_s_20140306_872.jpg

LM Start	14.22	Rating **	A/W	Issue No.	280 (cont)	
LM End	14.24	Issue Type +	Ma	Location *	LS	
Category	Earthen Levee			GPS Latitude/Longitude		
				Start		End
Item	Cracking			38.964848 °	38.965205 °	
				-121.920245 °	-121.920537 °	
DWR ID	DWR_RD0108_01_f_2013_280					
Action/Comments						
Monitor and have inspected by geotechnical engineer.

It appears to have some slope stability issues with the cracking. Fall 2013

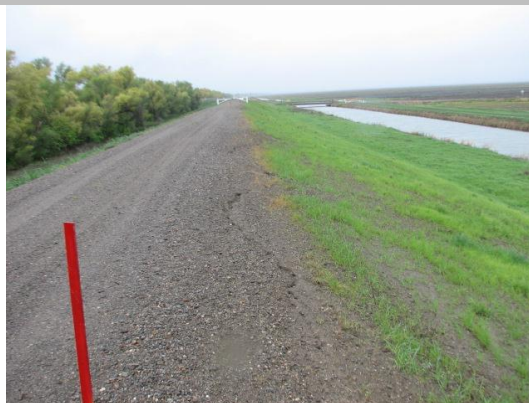
Photo 1 of 1 : johngw_s_20140401_697.jpg

LM Start	14.46	Rating **	M	Issue No.	12
LM End	14.46	Issue Type +	Ma	Location *	LS
Category	Earthen Levee			GPS Latitude/Longitude	
				Start	End
Item	Cracking			38.967243 °	38.967243 °
				-121.923407 °	-121.923407 °
DWR ID	DWR_RD0108_01_s_2014_12				
Action/Comments					
Schedule repair of subsidence prior to the next inspection.

Cracking along the shoulder of the crown. Some slope instability has occurred. Spring 2014

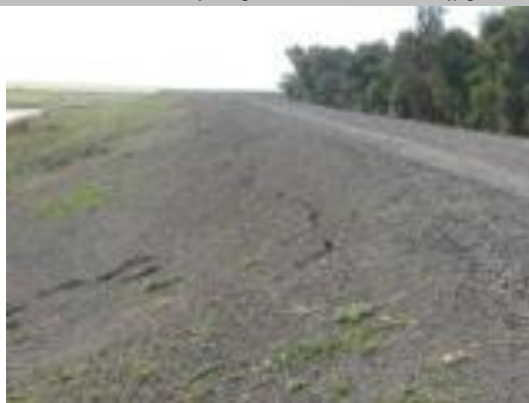
Photo 1 of 1 : johngw_s_20140306_862.jpg

LM Start	14.54	Rating **	A/W	Issue No.	2
LM End	14.54	Issue Type +	Ma	Location *	LS
Category	Earthen Levee			GPS Latitude/Longitude	
				Start	End
Item	Cracking			38.968032 °	38.968032 °
				-121.924480 °	-121.924480 °
DWR ID	DWR_RD0108_01_f_2012_2				
Action/Comments					
Monitor and have inspected by geotechnical engineer.

A crack running along the landside shoulder app. 50' long. Fall 2012

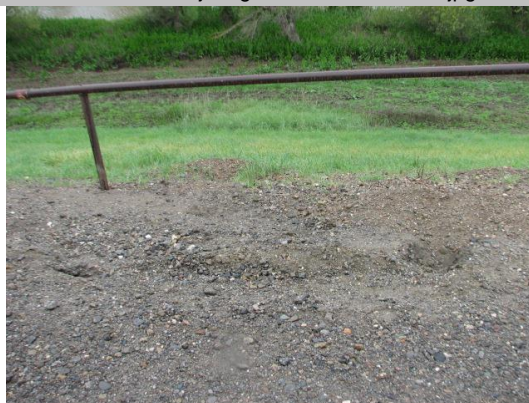
Photo 1 of 1 : johngw_s_20140401_698.jpg

LM Start	14.71	Rating **	M	Issue No.	13
LM End	14.71	Issue Type +	Ma	Location *	WS
Category	Earthen Levee			GPS Latitude/Longitude	
				Start	End
Item	Animal Control			38.969708 °	38.969708 °
				-121.926840 °	-121.926840 °
DWR ID	DWR_RD0108_01_s _ 2014_13				
Action/Comments					
No rodents visible, but rodent burrows visible; need to backfill and compact or grout burrows.

rodent holes along the waterside shoulder of the levee. Spring 2014

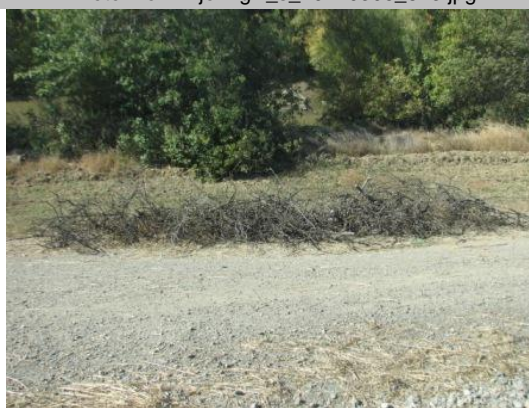
Photo 1 of 1 : johngw_s_20140306_873.jpg

LM Start	18.26	Rating **	M	Issue No.	281
LM End	18.26	Issue Type +	En	Location *	WS
Category	Earthen Levee			GPS Latitude/Longitude	
				Start	End
Item	Encroachments			39.006497 °	39.006497 °
				-121.973158 °	-121.973158 °
DWR ID	DWR_RD0108_01_f _ 2013_281				
Action/Comments					
Prunings

Piles of prunings are at the waterside berm. Fall 2013

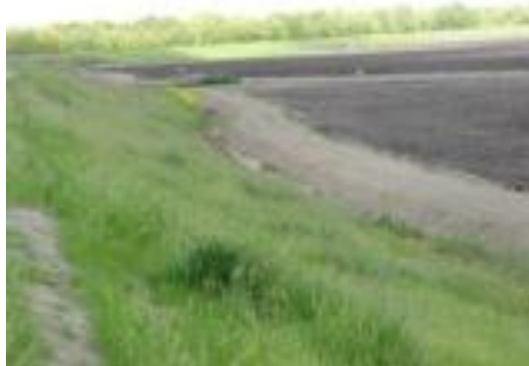
Photo 1 of 2 : johngw_s_20140306_865.jpg

LM Start	18.88	Rating **	M	Issue No.	6
LM End	19.60	Issue Type +	En	Location *	LS
Category	Earthen Levee			GPS Latitude/Longitude	
				Start	End
Item	Encroachments			39.013245 °	39.021302 °
				-121.980795 °	-121.988557 °
DWR ID	DWR_RD0108_01_s _ 2012_6				
Action/Comments					
Ditch

Agricultural ditch

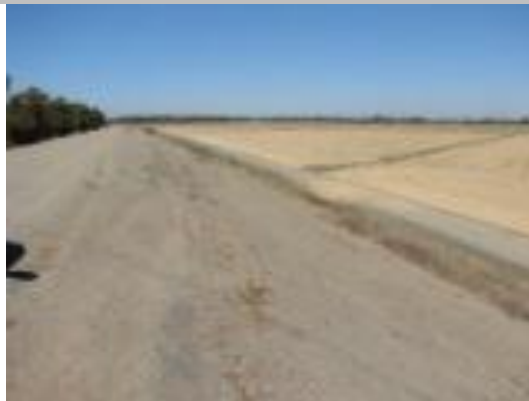
Photo 2 of 2 : johngw_s_20140306_866.jpg

LM Start	18.88	Rating **	M	Issue No.	6 (cont)	
LM End	19.60	Issue Type +	En	Location *	LS	
Category	Earthen Levee			GPS Latitude/Longitude		
				Start		End
Item	Encroachments			39.013245 °	39.021302 °	
				-121.980795 °	-121.988557 °	
DWR ID	DWR_RD0108_01_s _ 2012_6					
Action/Comments						
Ditch

Agricultural ditch along toe of landside. Photo taken fall 2011.

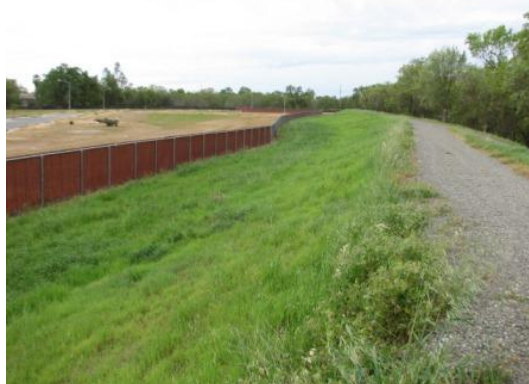
Photo 1 of 1 : johngw_s_20140401_684.jpg

LM Start	0.00	Rating **	M	Issue No.	1
LM End	0.28	Issue Type +	Ma	Location *	LS
Category	Earthen Levee			GPS Latitude/Longitude	
				Start	End
Item	Vegetation			38.799108 °	38.796232 °
				-121.724498 °	-121.727921 °
DWR ID	DWR_RD0108_02_s _ 2014_1				
Action/Comments					
Control annual grass and weeds on the levee slopes and easements.

Tall grasses, weeds partially blocks visibility. Spring 2014

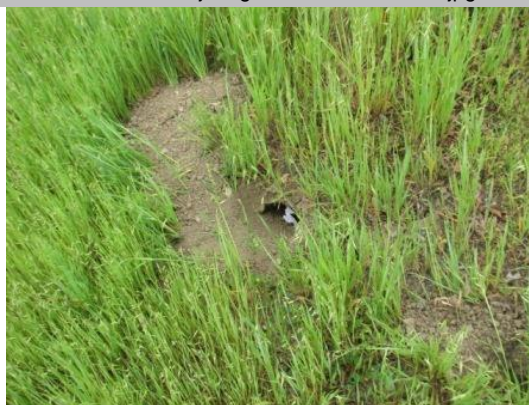
Photo 1 of 1 : johngw_s_20140306_875.jpg

LM Start	0.01	Rating **	A/W	Issue No.	3
LM End	0.01	Issue Type +	Ob	Location *	LS
Category	Earthen Levee			GPS Latitude/Longitude	
				Start	End
Item	Animal Control			38.798992 °	38.798992 °
				-121.724643 °	-121.724643 °
DWR ID	DWR_RD0108_02_s _ 2013_3				
Action/Comments					
No rodents visible, but rodent burrows visible; need to backfill and compact or grout burrows.

No rodents but holes need to be backfilled. Spring 2013

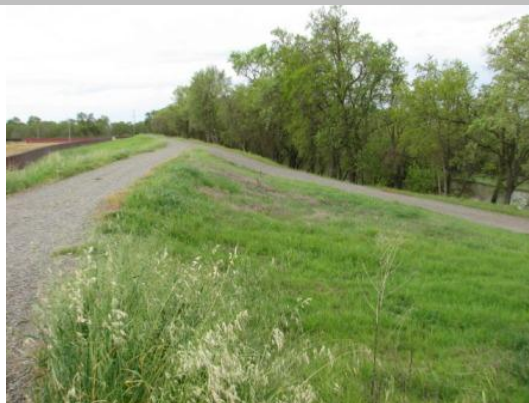
Photo 1 of 1 : johngw_s_20140401_685.jpg

LM Start	0.02	Rating **	M	Issue No.	5
LM End	0.28	Issue Type +	Ma	Location *	WS
Category	Earthen Levee			GPS Latitude/Longitude	
				Start	End
Item	Vegetation			38.798956 °	38.796230 °
				-121.724679 °	-121.727922 °
DWR ID	DWR_RD0108_02_s _ 2014_5				
Action/Comments					
Control annual grass and weeds on the levee slopes and easements.

Tall grasses, weeds partially blocks visibility. Spring 2014

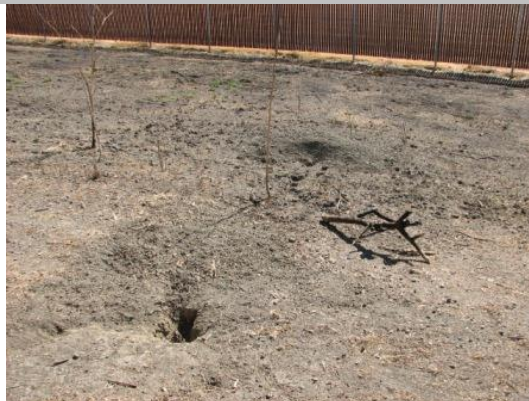
Photo 1 of 1 : johngw_s_20140306_876.jpg

LM Start	0.09	Rating **	A/W	Issue No.	4
LM End	0.09	Issue Type +	Ob	Location *	LS
Category	Earthen Levee			GPS Latitude/Longitude	
				Start	End
Item	Animal Control			38.798196 °	38.798196 °
				-121.725660 °	-121.725660 °
DWR ID	DWR_RD0108_02_f_2012_4				
Action/Comments					
No rodents visible, but rodent burrows visible; need to backfill and compact or grout burrows.

A couple of rodent holes on the landside slope. Fall 2012
